# Reduce RF Interference with Gamma Suppressor Boot

by [Cameron Lanier](#) | Mar 26, 2021 | [Cable Protection](#), [Gamma News](#), [RF Weatherproofing](#)

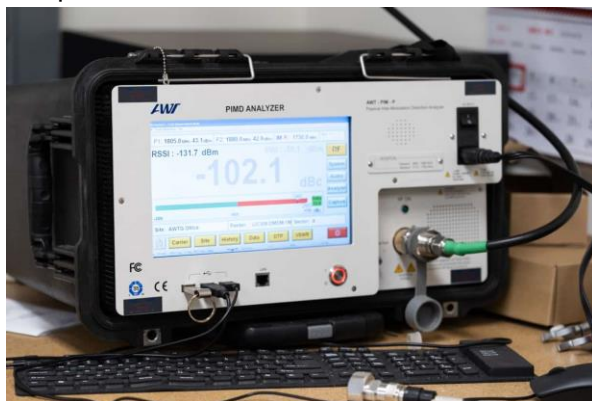
**PIM Testing Equipment**

Below you can see some of the real-world equipment we utilized during the material testing phase of this process.

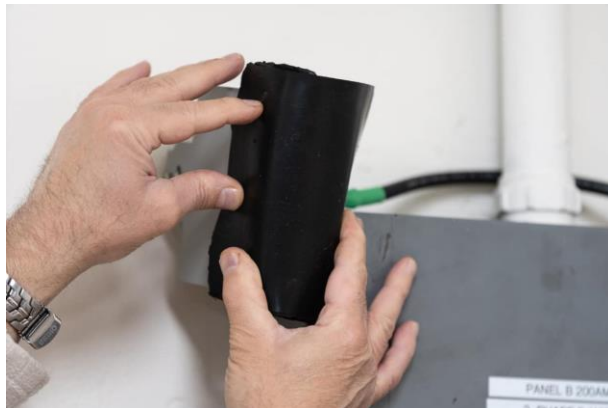
The next step was to test out different materials and see if those materials would impact the strength of those transmitted frequencies. Typically, we would take the material and place it over the antenna unit and check the spectrum analyzer for a difference in the strength of the signal.

### **Antenna covered with material**

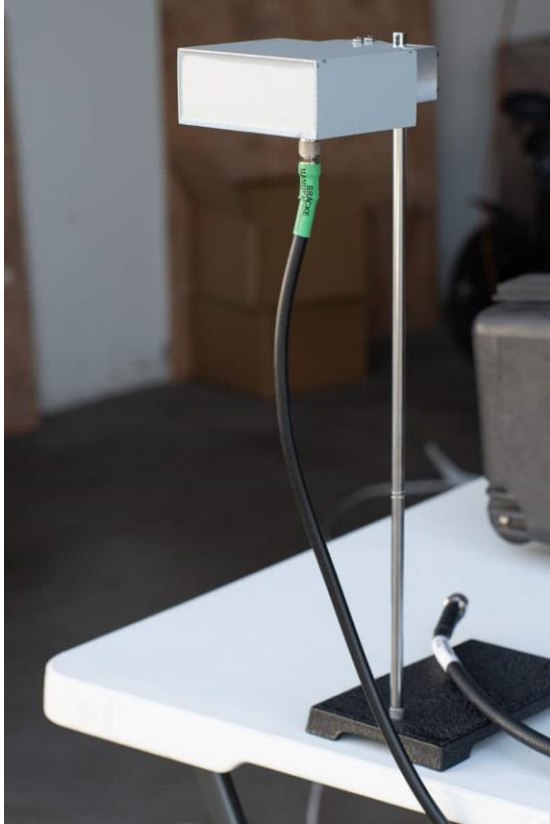
**Gamma Suppressor Boot**

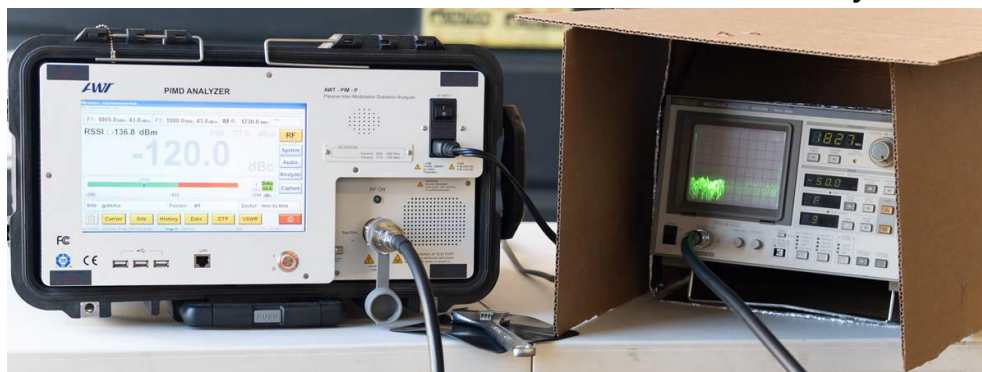
### PIM Testing Equipment next to Spectrum Analyzer

Like before, the spectrum analyzer would tell us how much of the transmitted signals were being picked up and how much was attenuated by the suppressor boot. Note, in the photo above that we covered the spectrum in two different boxes, one of which is covered in foil, to shield it from any outside interference. We did this despite the fact that it should only be showing frequencies coming via the cable from the horn antenna, but we wanted to make sure we were eliminating any potential interference.

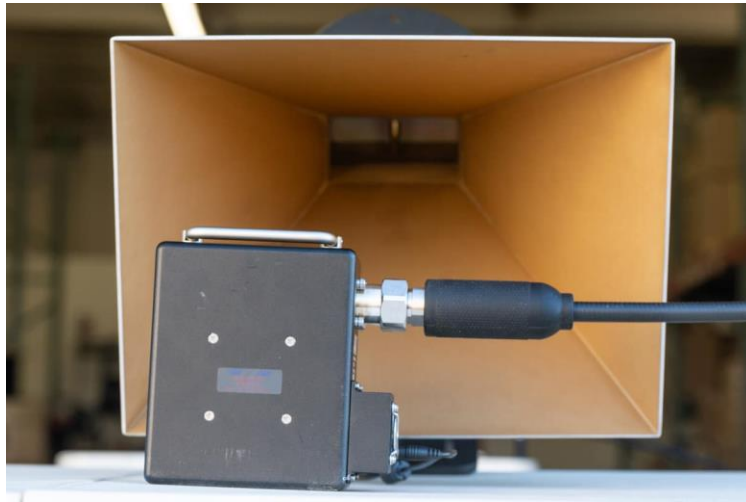
The only thing left to do now was to cover the leaky connection with the Suppressor Boot and see if there was a drop in intensity of any significance on the spectrum analyzer.
